February 28, 1997

Issue Alert Letter #24

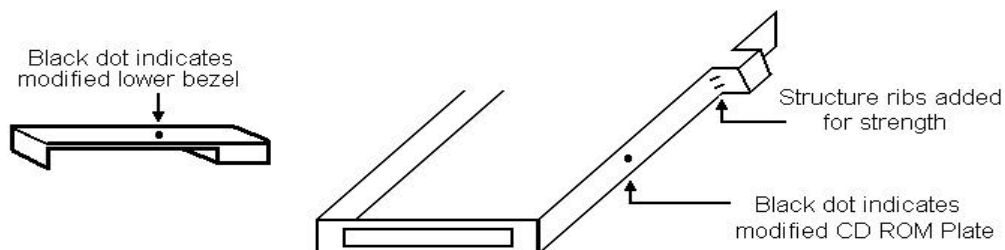
To see if the CD-ROM drive has been modified, look for the structure ribs which have been added to the cam bend in the new version of the CD-ROM Plate as shown in the illustration below. Additionally, the black dots, also shown in the illustration, should be added in indelible ink whenever a CD-ROM drive assembly is modified by a Service Provider.

Remove the lower bezel by pulling the upper bezel slightly away from the assembly, thus releasing the lower bezel. Once removed be sure that any remaining adhesive tape is removed from the base of the CD-ROM drive. Remove the paper strip exposing the adhesive tape provided on the inside of the new lower bezel and install it on the assembly. Remove the original CD-ROM plate and replace it with the modified part. Mark the new components as shown above.

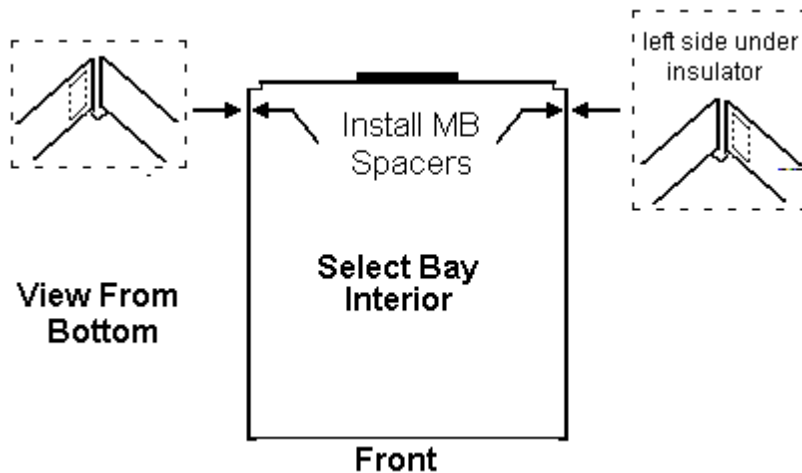
Attach the two new mylar spacers along the back corner of each side in the Select Bay Frame as illustrated below. The long side of the rectangular spacers should be positioned vertically from the top of the Select Bay to about 1/4" from the bottom edge. Keep in mind that access to the inside of the Select Bay is from the bottom.

Replace the original Lock Hook with the modified part, carefully replacing the spring between the Lock Hook and base. Replace the System board and Select Bay Frame into the base ensuring that the Lock Hook is fitted up through the appropriate slot in the Frame. Be sure that the Lock Hook slides freely and is spring loaded into the locked position. Reassemble the system and test. Make sure that the CD-ROM drive will seat and latch properly into the Select Bay.
